LONGTERM REPORT HONDA CX500

After 13,000 Miles and One Year, Our Opinion of the CX500 Hasn't Changed.

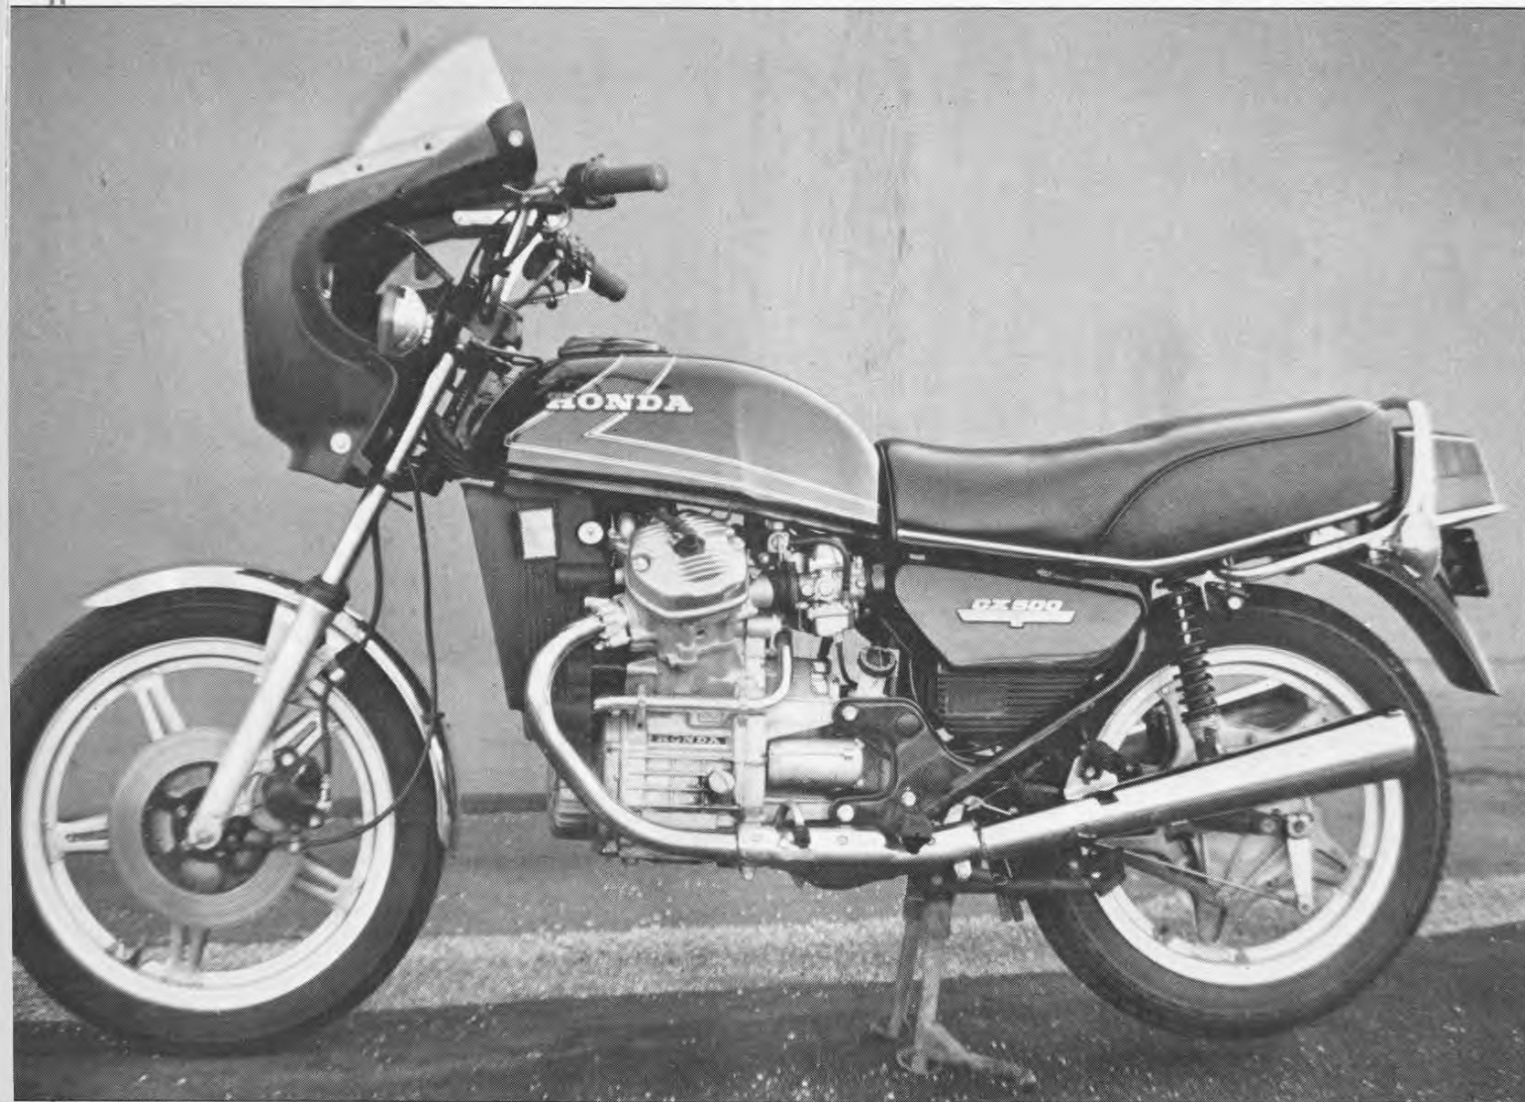
After 13,000 miles, the CX500 still cleans up nicely. Visible here are the Jardine mufflers, Krauser fairing and the trimmed and recovered seat.

We had even less luck with a custom seat. As the photos show, the CX seat has lost much of its step and the flashy covering and sculpture. A local shop did the work, trimming down the rear portion and recovering the seat for \$50 cheaper than a store-bought custom.

Flaw here was simply that our man didn't make himself clear. He wanted a flat, level seat, front to back. He got a not quite flat seat that is level *on the workbench*. What he forgot to tell the shop was that the seatpan mounts with a slope toward the front. The principle, that of having a good shop re-do your machine's seat to fit your seat, works. The execution in this case wasn't as good as the principle.

Jardine slip-on mufflers went on at about 5000 miles. They reduced the quarter-mile time by several tenths of a second, sound lovely and haven't gotten louder or rusted or anything. After the first report, though, we noticed that one muffler is markedly higher than the other. Why, we don't know. Doesn't bother us much, although other riders have asked why the

The Krauser fairing is much the same, as we adapted it and the hardware from a kit designed to go on another model Honda. The fairing has been worn with four sets of bars—one of the staff has this thing about The Perfect Bars—and it has held up well. Some of us like it, some don't. So far, nobody has said it ruins the looks of the CX. From Bob Beach, 2803 W. River, Grand Island, N.Y. 14072.

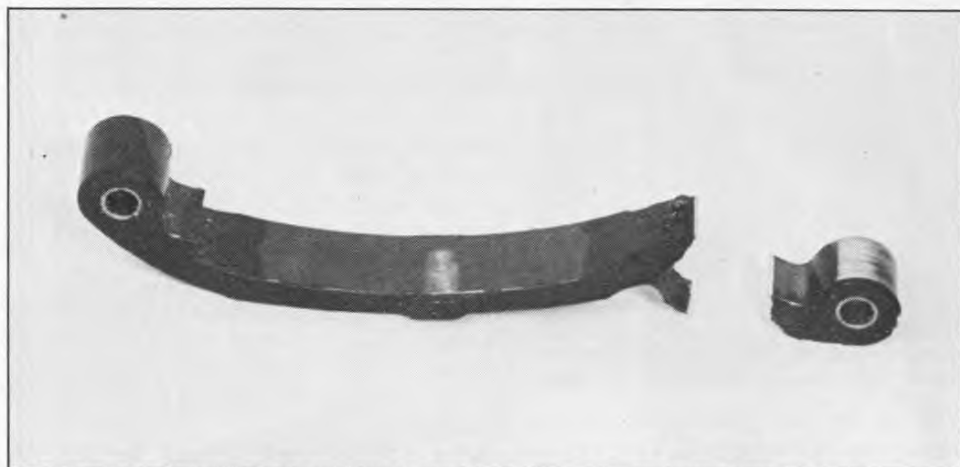
Slipper for the timing chain tensioner broke just below its pivot. Lots of noise, no damage and an expensive repair.

During a lunch stop in Arizona, odo reading 5600 miles, the valves sounded loose. They weren't. Perhaps the timing chain? No. Thinking of the earlier weak point within the chain tensioner, we checked with an Arizona dealer. Not for days, they said.

Faith did it. The CX made the 500 miles, noisy but intact. A teardown showed that although the tensioner bolt was intact the slipper itself had broken at the pivot. The slipper and the timing chain—the latter as a precaution—were replaced. The bill was \$120 for labor, \$74.75 for parts.

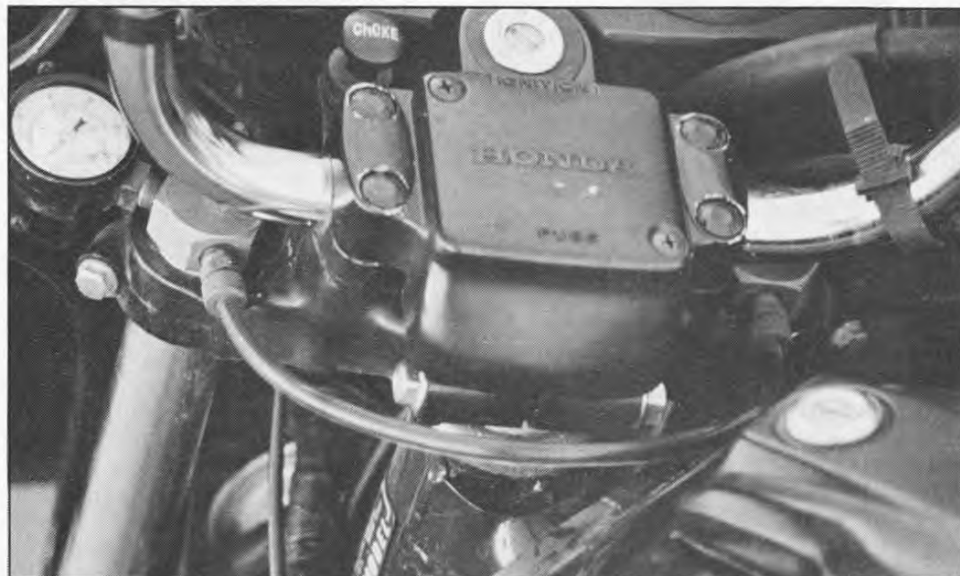
Air caps for the forks help firm up the front under braking. The kit works well and the pressure showing on the gauge hasn't dropped one psi in months.

On the CX, the caps worked well, but not as well as hoped. Air pressure is an accessory spring, with progressive rate. Our hope was to keep the CX's comfy ride while firming the front end under heavy braking. The pressure did some good, using 12 psi, but with higher pressure the ride suffered and with 12 psi or less, the front still dips.

The caps, fittings, hoses and gauges, though, are still in top shape. Haven't leaked or lost pressure in 10 months. From Helmet House, 2115 Colorado Blvd, Santa Monica, Calif. 90404.

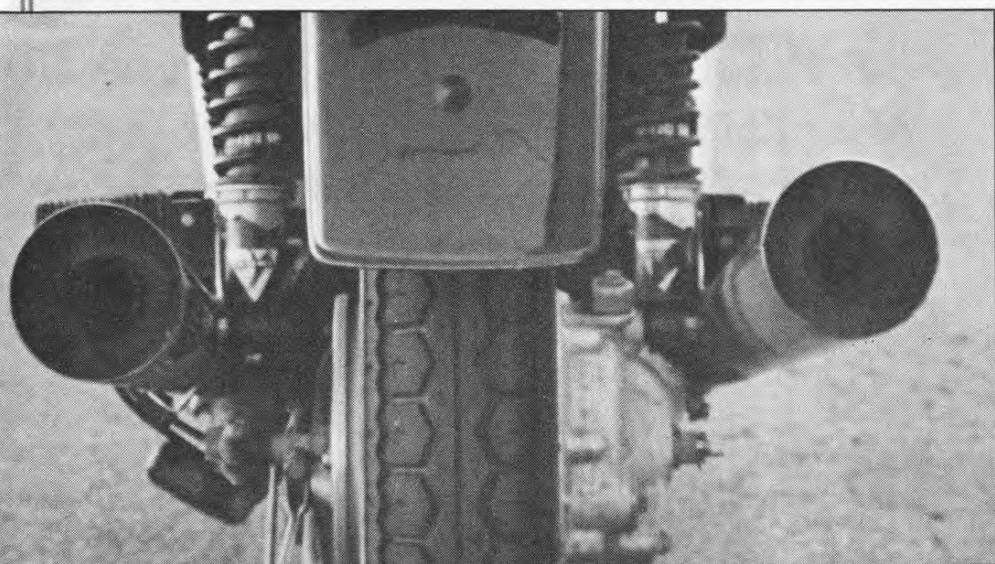
Mufflers mount off the brackets that also hold the passenger pegs. There are slots and tabs and for some reason, when the slots were opened up to take the pegs and pipes, the right muffler was higher than the left.
